X-rays ensure bone-free chicken fillet

The installation of two Ishida X-ray inspection systems at the Rose Poultry factory in Skovsgaard, Denmark, has fully automated the previously manual process of checking chicken fillets for bones and enabled up to 10 operators to be re-deployed elsewhere in the factory

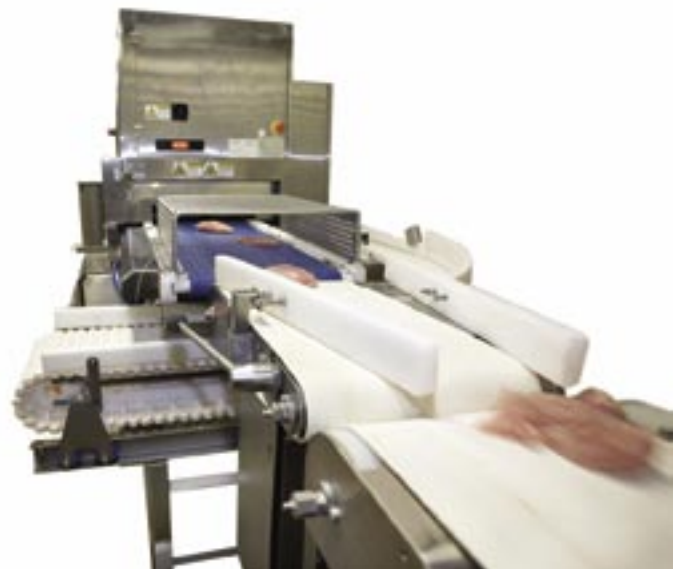
Rose Poultry has installed an Ishida IX-GA-2475 X-ray inspection system on each of its two frozen chicken fillet lines.

Rose has now installed an Ishida IX-GA-2475 X-ray inspection system on each of its two frozen chicken fillet lines at its Skovsgaard plant, near Aalborg, in the north of the country. This development followed consultations with Ishida and its local agent, and has resulted in better quality assurance coupled with major reductions in the cost of processing.

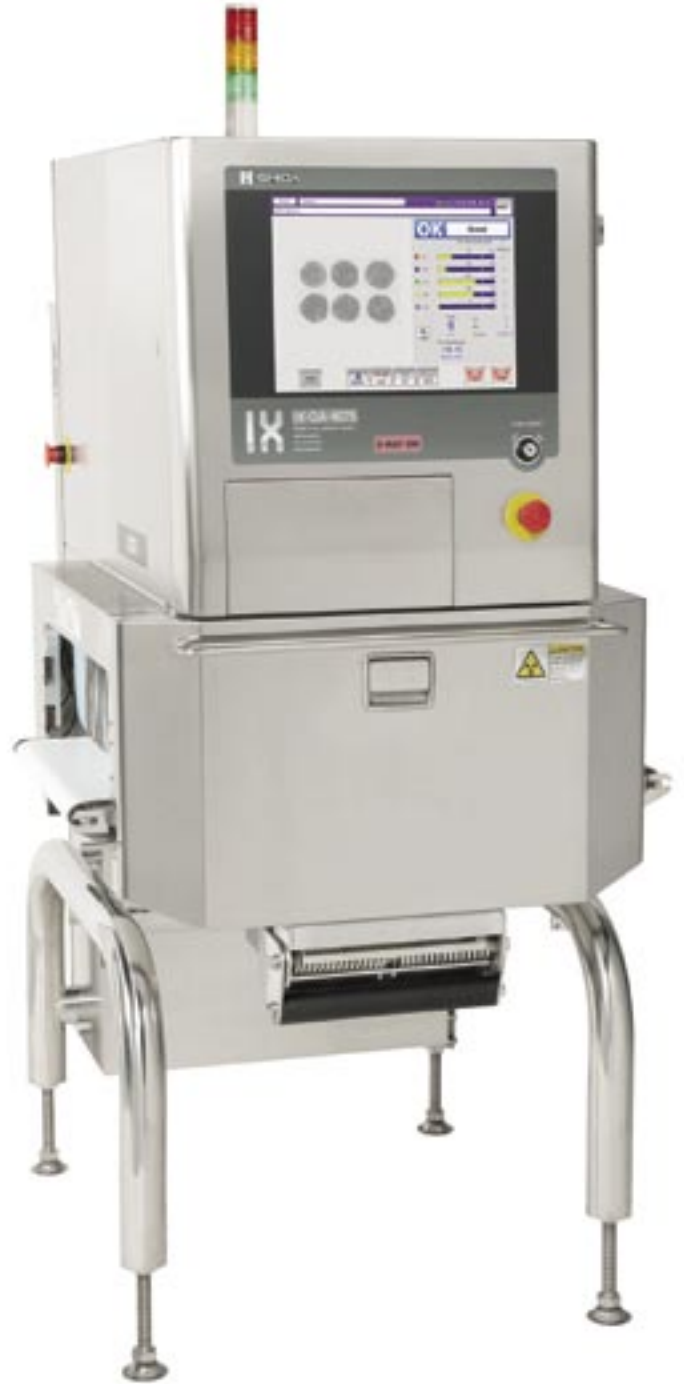
Fragments as small as 0.3mm in diameter can be detected by the Ishida IX-GA-2475 X-ray inspection system, well below the range of likely manual/visual detection.

Fragments as small as 0.3mm in diameter can be detected, well below the range of likely manual/visual detection. The sensitivity of the IX-GA has been established in an independent evaluation of six leading X-ray inspection systems, conducted by a major European meat research institute.
